NASA CR-135078
R76AEG461

FIBER COMPOSITE FAN BLADE IMPACT IMPROVEMENT PROGRAM

Final Report

GENERAL ELECTRIC COMPANY

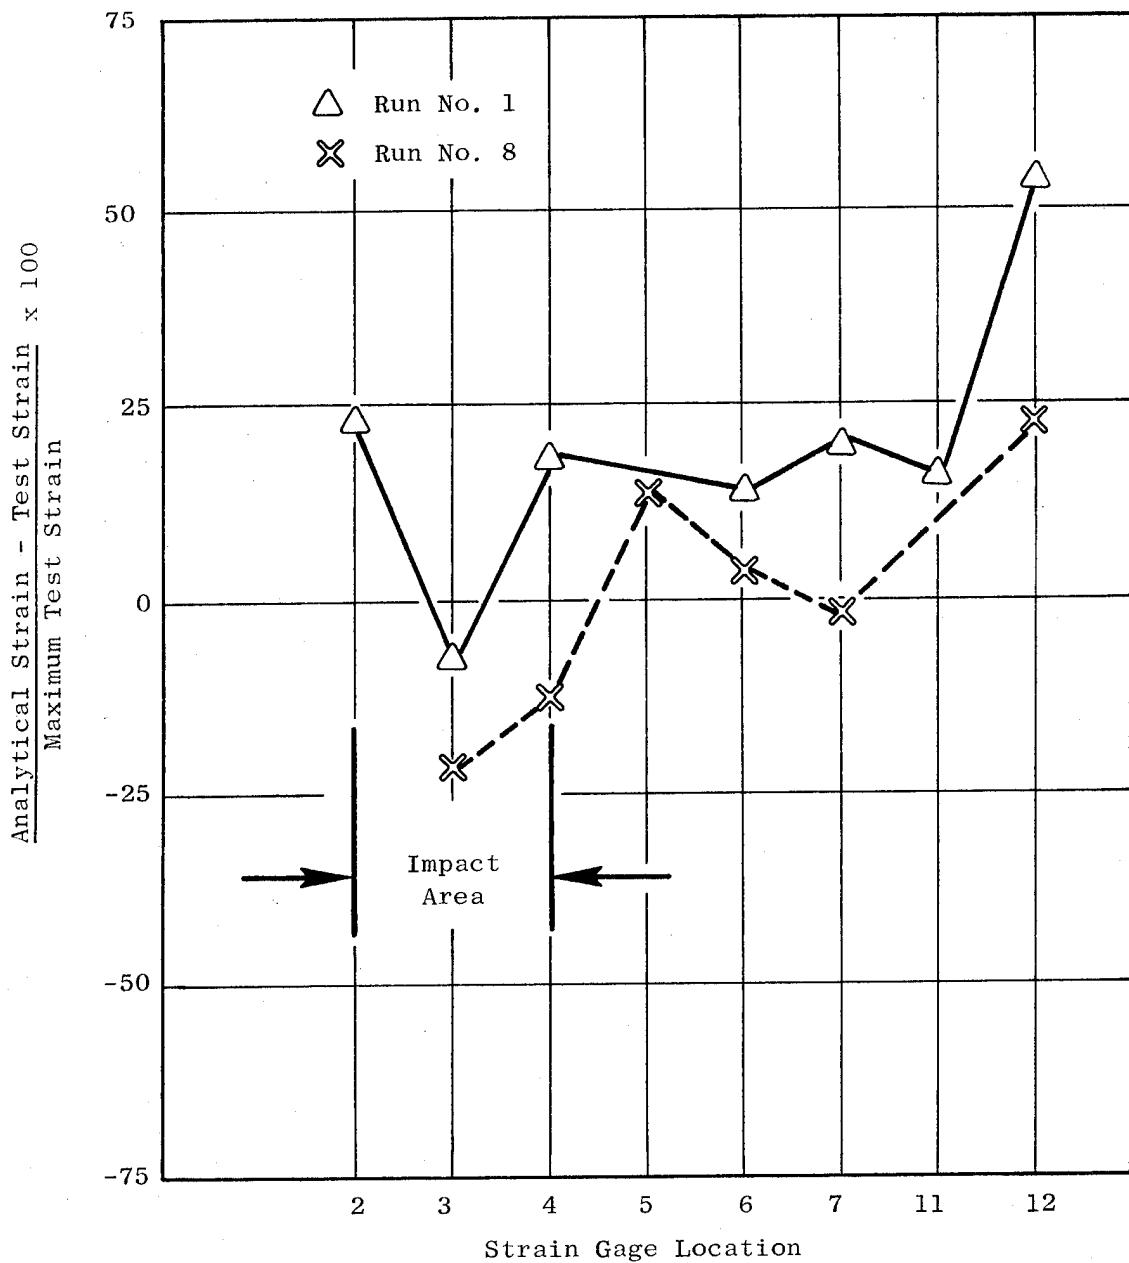
Figure 52. Analytical Strain Versus Test Strain Runs 1 and 8.

From Figure 52, it can be seen that, in general, the analytical and test data agree within +25 percent and -12 percent. The largest error occurred at gage location number 12 for both run 1 and run 8. One possible reason for this larger error at this location is the relatively coarse finite element model in the root area of the blade.

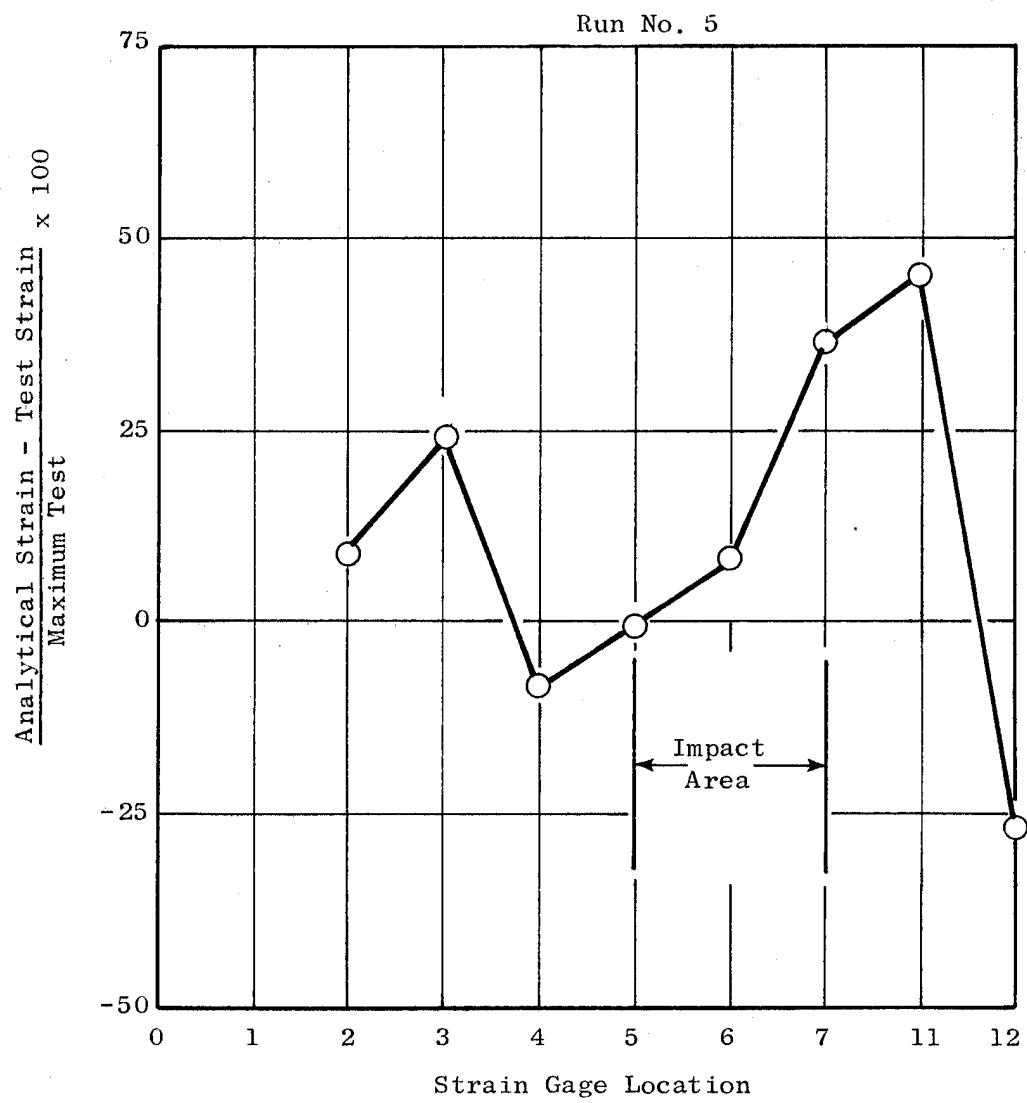
Figure 53. Analytical Strain Versus Test Strain Run 5.

The analytical versus test strain comparison for run number 5, shown in Figure 53, exhibits somewhat poorer agreement than for runs 1 and 8. This is a result of the fact that the impact occurred at 37 percent span, while the same bird properties (spring constant and damping characteristics) were used as had been used for the impacts at 75 percent span.

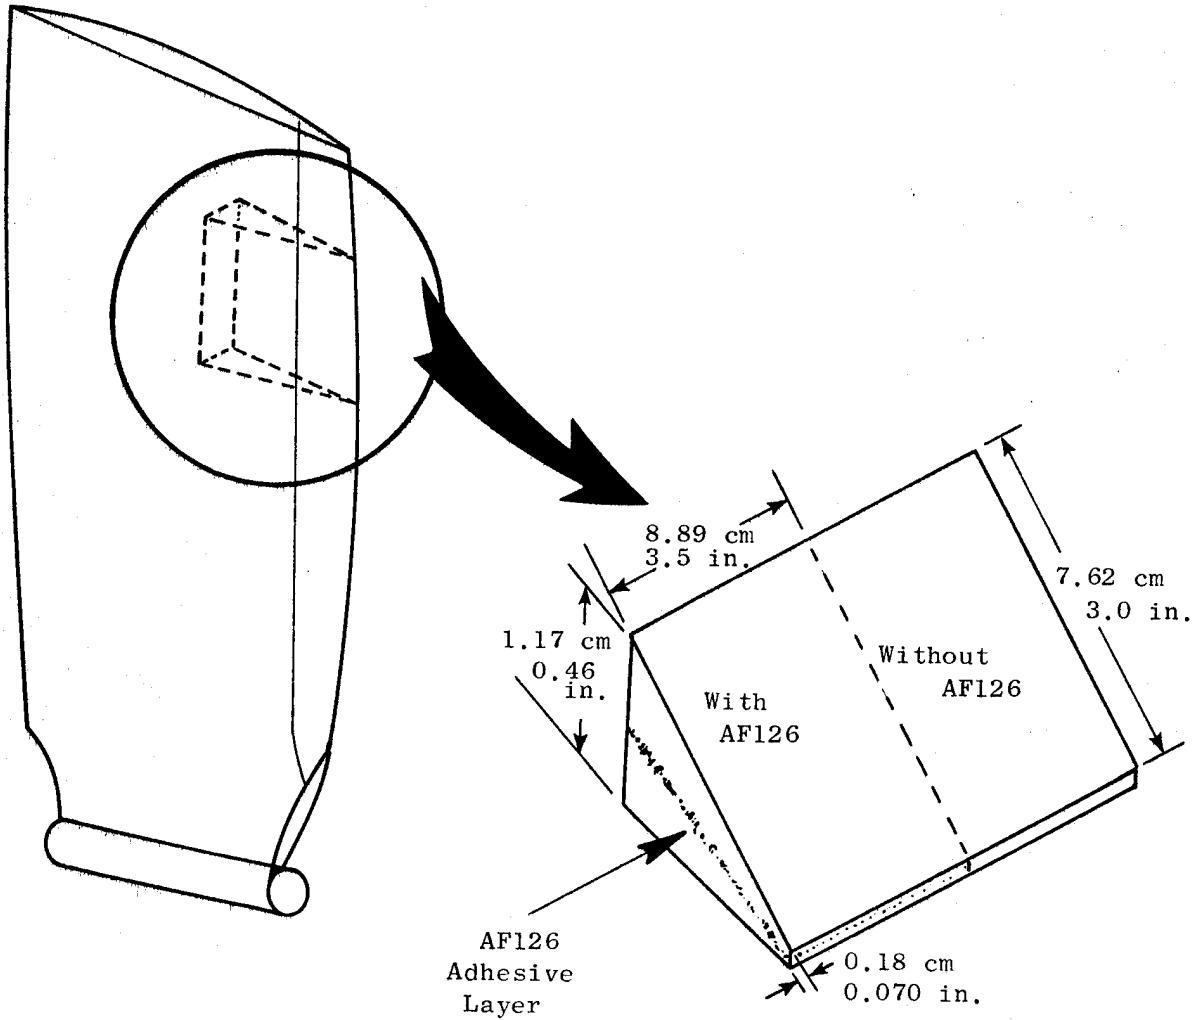
Figure 66. AF126 Adhesive Panel.

which exist in an actual blade and thereby to potentially improve the shear strength at this location. Short-beam shear specimens were tested at an L/d ratio of 5:1. The data showed no improvement in shear strength by using the AFL26 layer; however, examination of the specimens revealed that failures occurred in the outer plies and not the center. The failures were of a tensile nature rather than shear. Additional specimens were then tested using L/d ratios of 3:1 and 2:1. After testing a single specimen at 3:1 and examining the specimen, the failure mode was still tensile. The remaining specimens were then tested at 2:1. Still, failure did not occur along the center plane and no differences were noted in test data values. In addition, due to the tapered nature of the specimens, testing of the specimens in the short-beam shear setup was difficult because the panel tended to slide when the load was applied. In view of the above difficulties, it was not possible to reach any definite conclusions relative to the adhesive core panel. In an actual blade with a complex molding, improvement by this technique might offer some advantages.

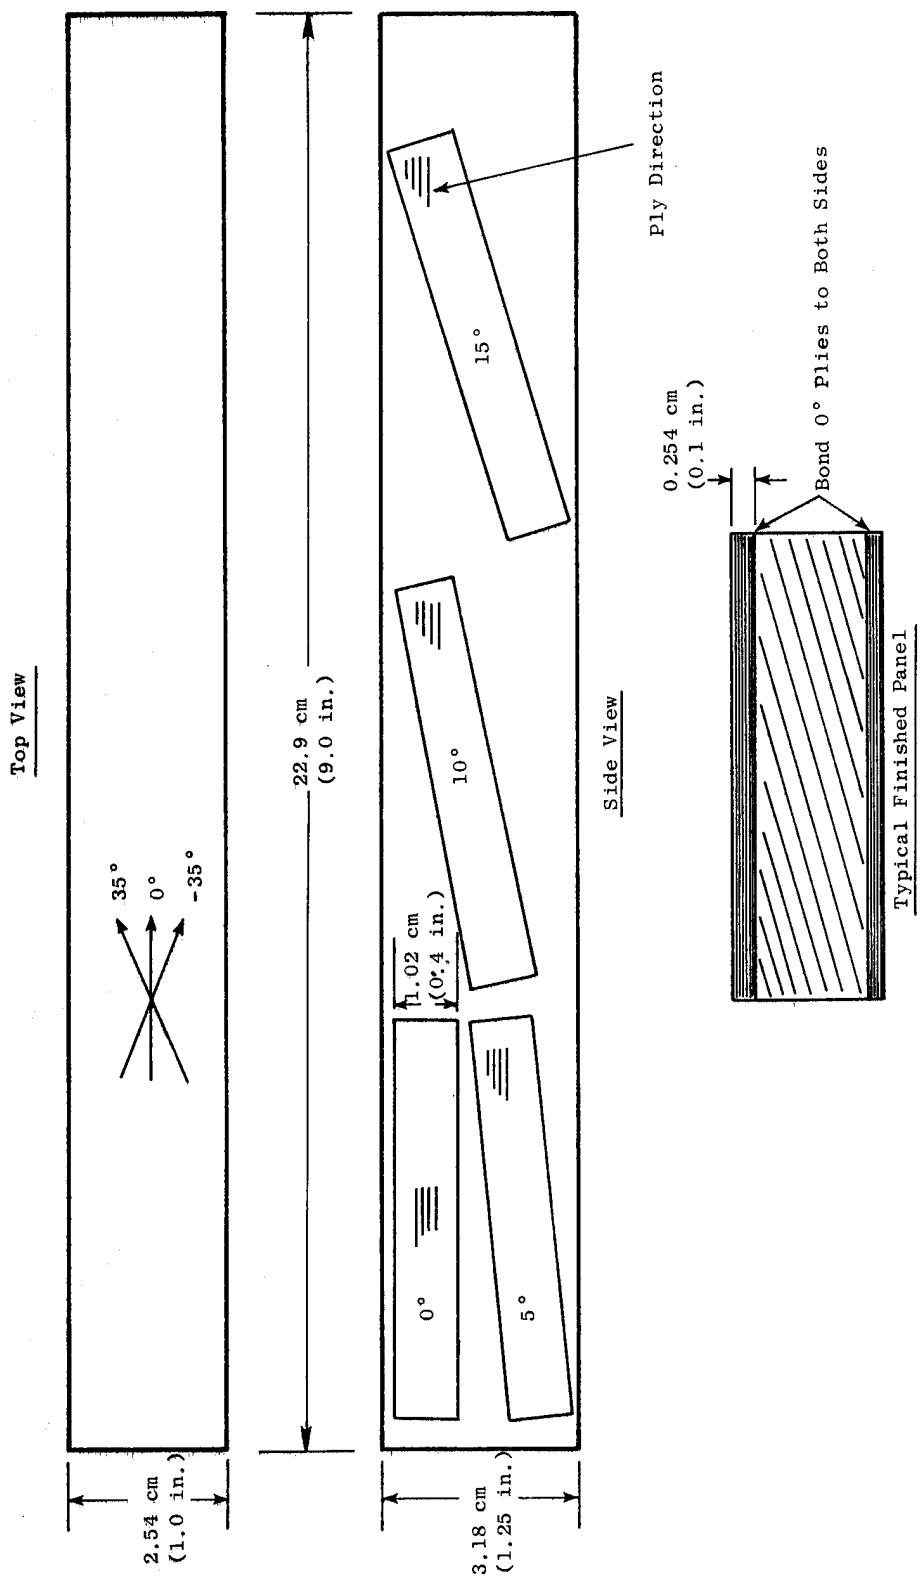
Figure 67. "Shingling" Radial Test Panel.

These results show that shingled angles do not significantly decrease or increase the shear strength of flat panels. Shingled plies however, may offer the potential for improved blade strength by eliminating the potentially weak center ply ends characteristic of conventional blade layups.

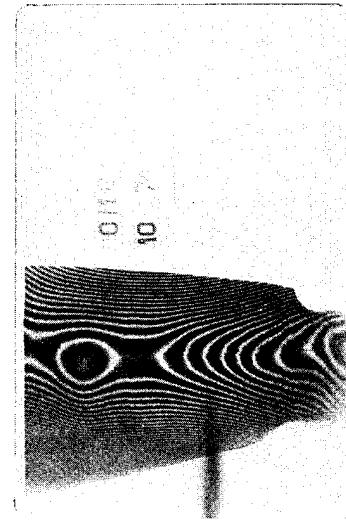
(c) Concave - Root
Slight Disconti-
nuity Due to Ply
Slippage

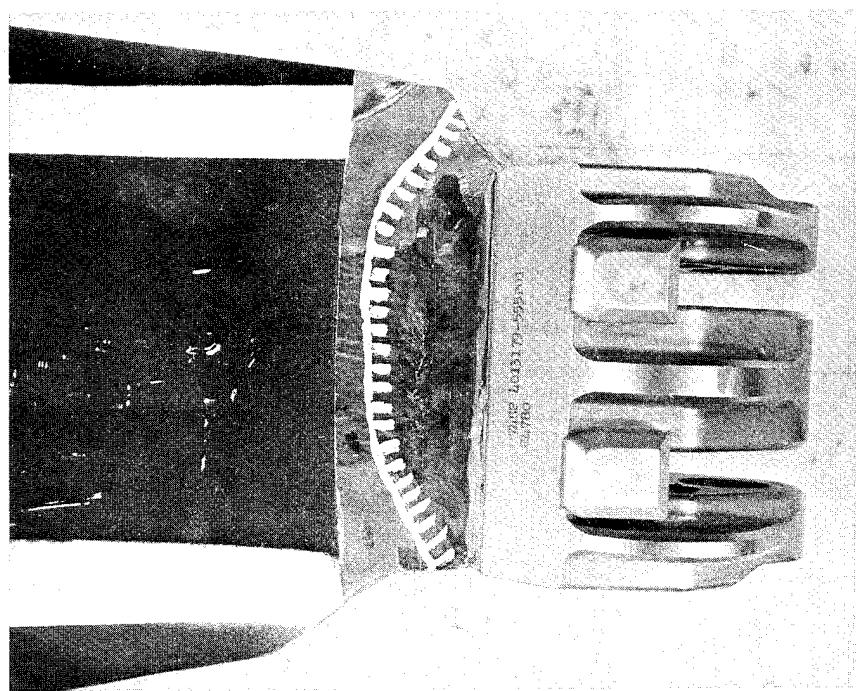
Figure 87. Pin Root Blade Root Delamination, Unbonded Area.

Before impact testing, the pin root blade was run up to 3800 rpm (117 percent of mechanical design), to demonstrate overspeed capability. Following this test, a delamination in the composite dovetail was detected. No damage was detected on previous runs at 3200 rpm. Figure 86 shows a photograph of the delamination at the leading edge using die penetrant. Figure 87 shows the extent of the delamination as defined by ultrasonic inspection; the area below the white ticked line representing the area of delamination. After a review of the extent of the delamination, it was decided to proceed with the impact test of the blade. Since the damage was confined to the root area of the blade, the ability of the airfoil portion of the blade to absorb the impact should be unchanged. Therefore, any impact advantage associated with the pin root concept could still be identified.

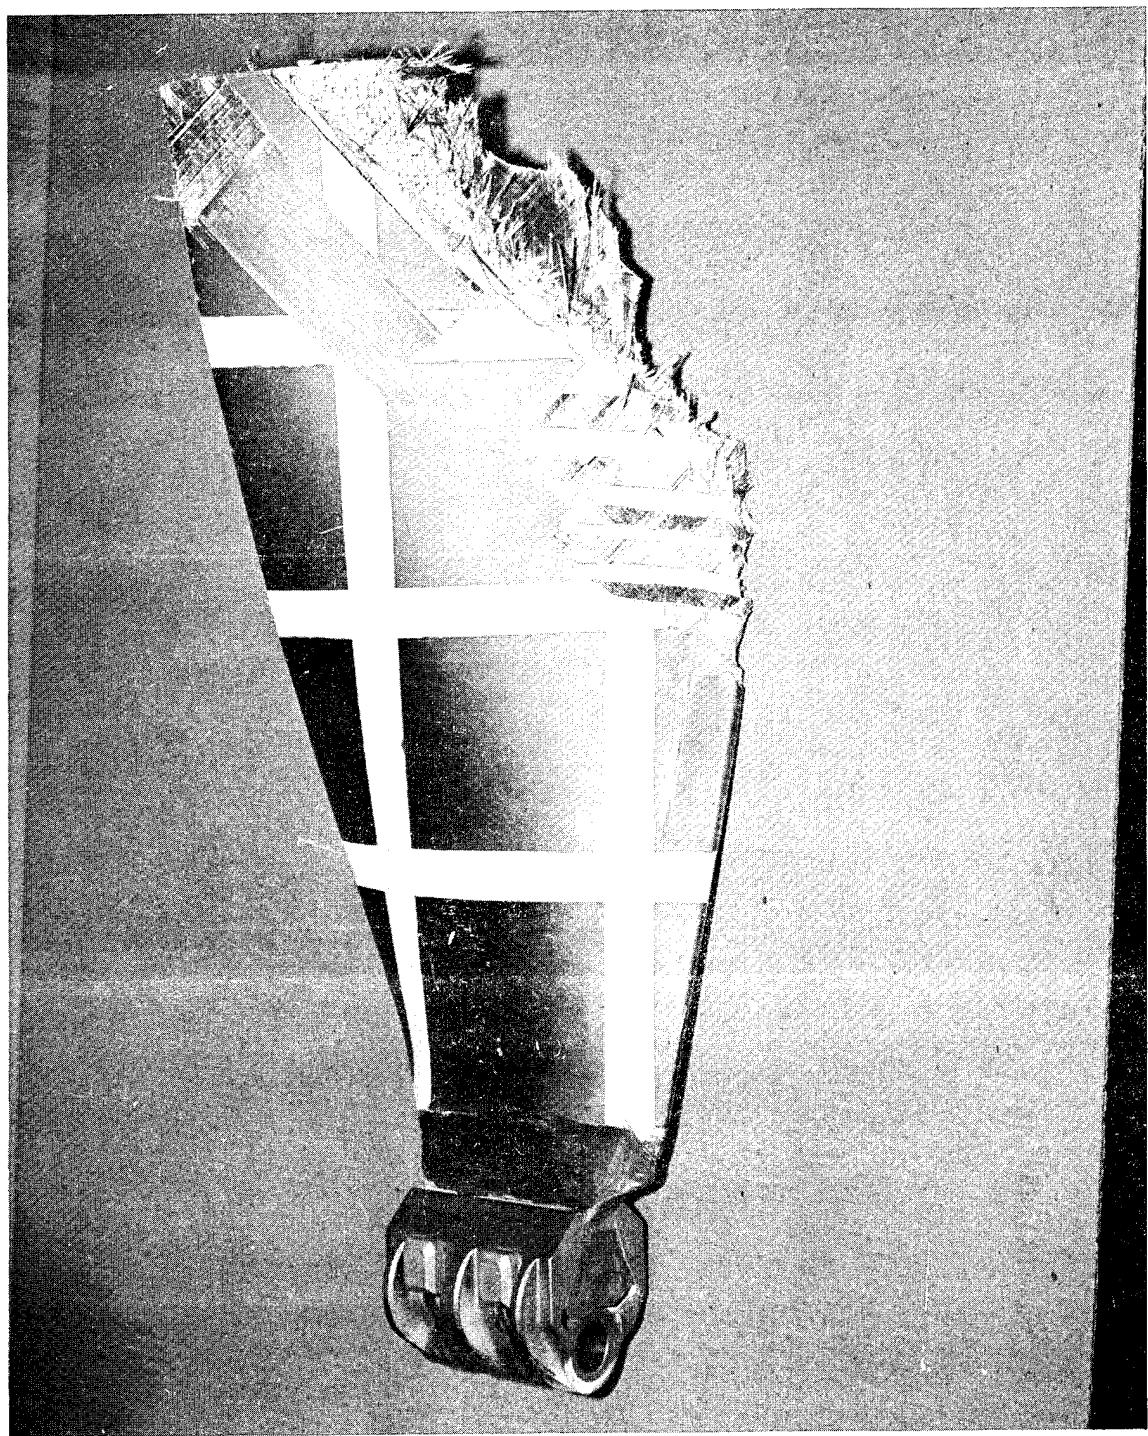
Figure 88. Pin Root Blade after Impact.

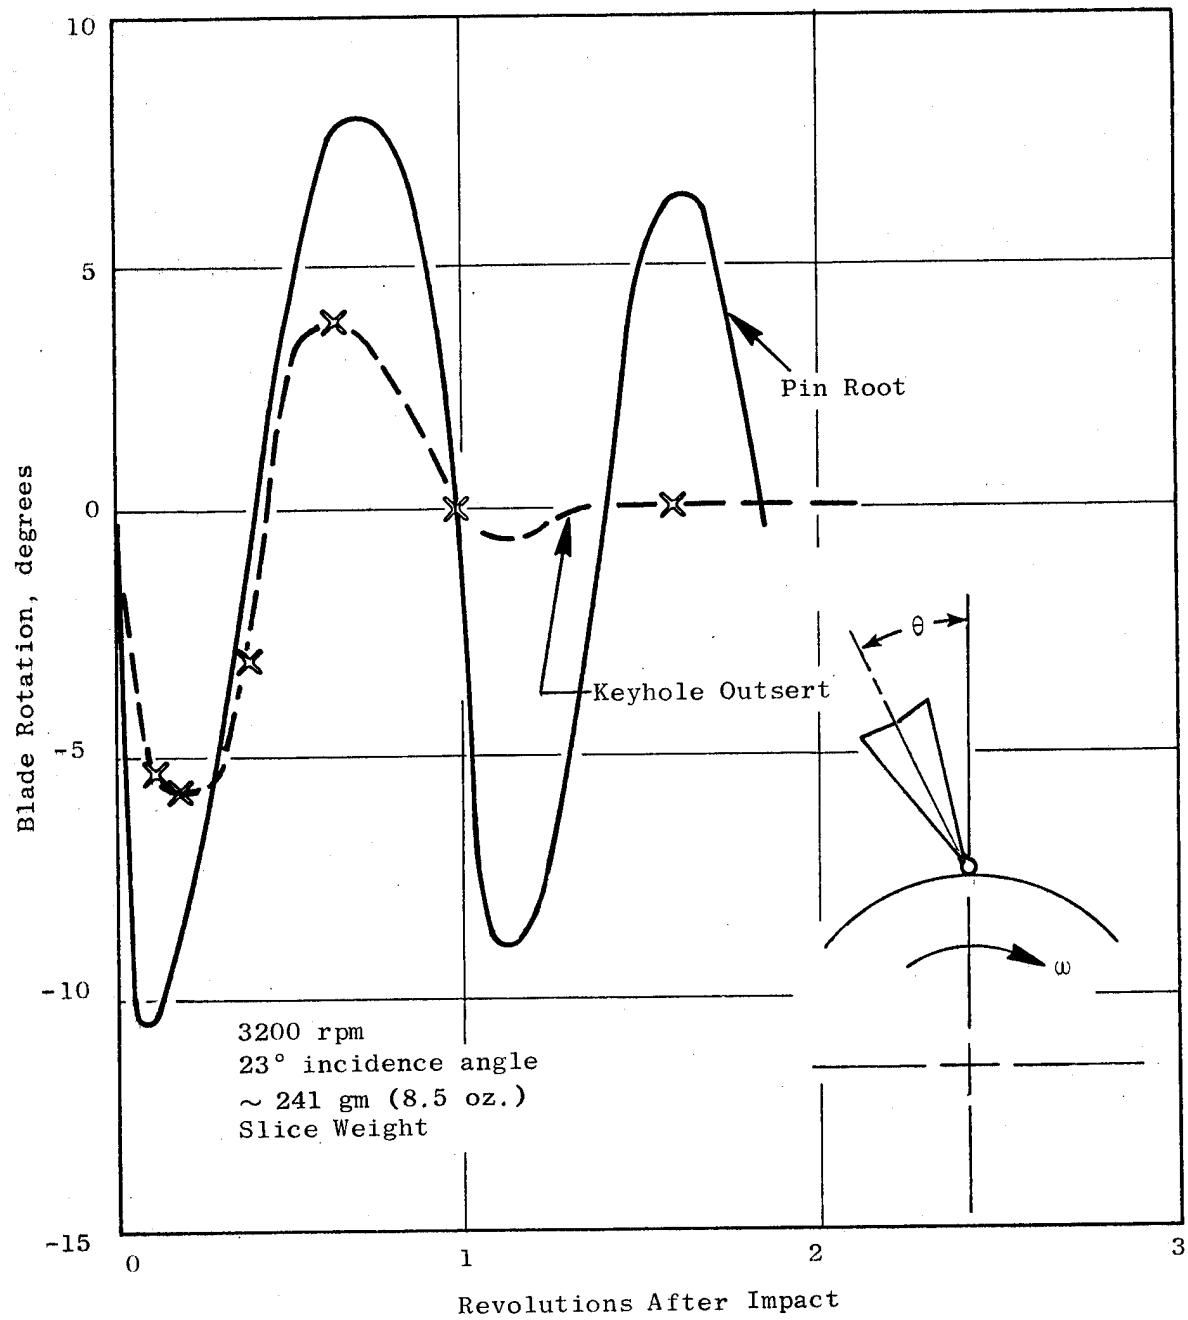
As can be seen from the figure, the pin root blade rotated to an initially higher angle than the keyhole blade, about 11 degrees versus five to six degrees. Also, the pin root blade rotation damped out much more slowly than the keyhole blade; this is due to the reduced friction associated with the pin. These data show that the pin root concept might be helpful for a particular blade design if the blade root was susceptible to root failure upon impact since the pin root has low resistance to rotation.

Figure 89. Rotation after Impact for Pin Root and Keyhole Outserts.

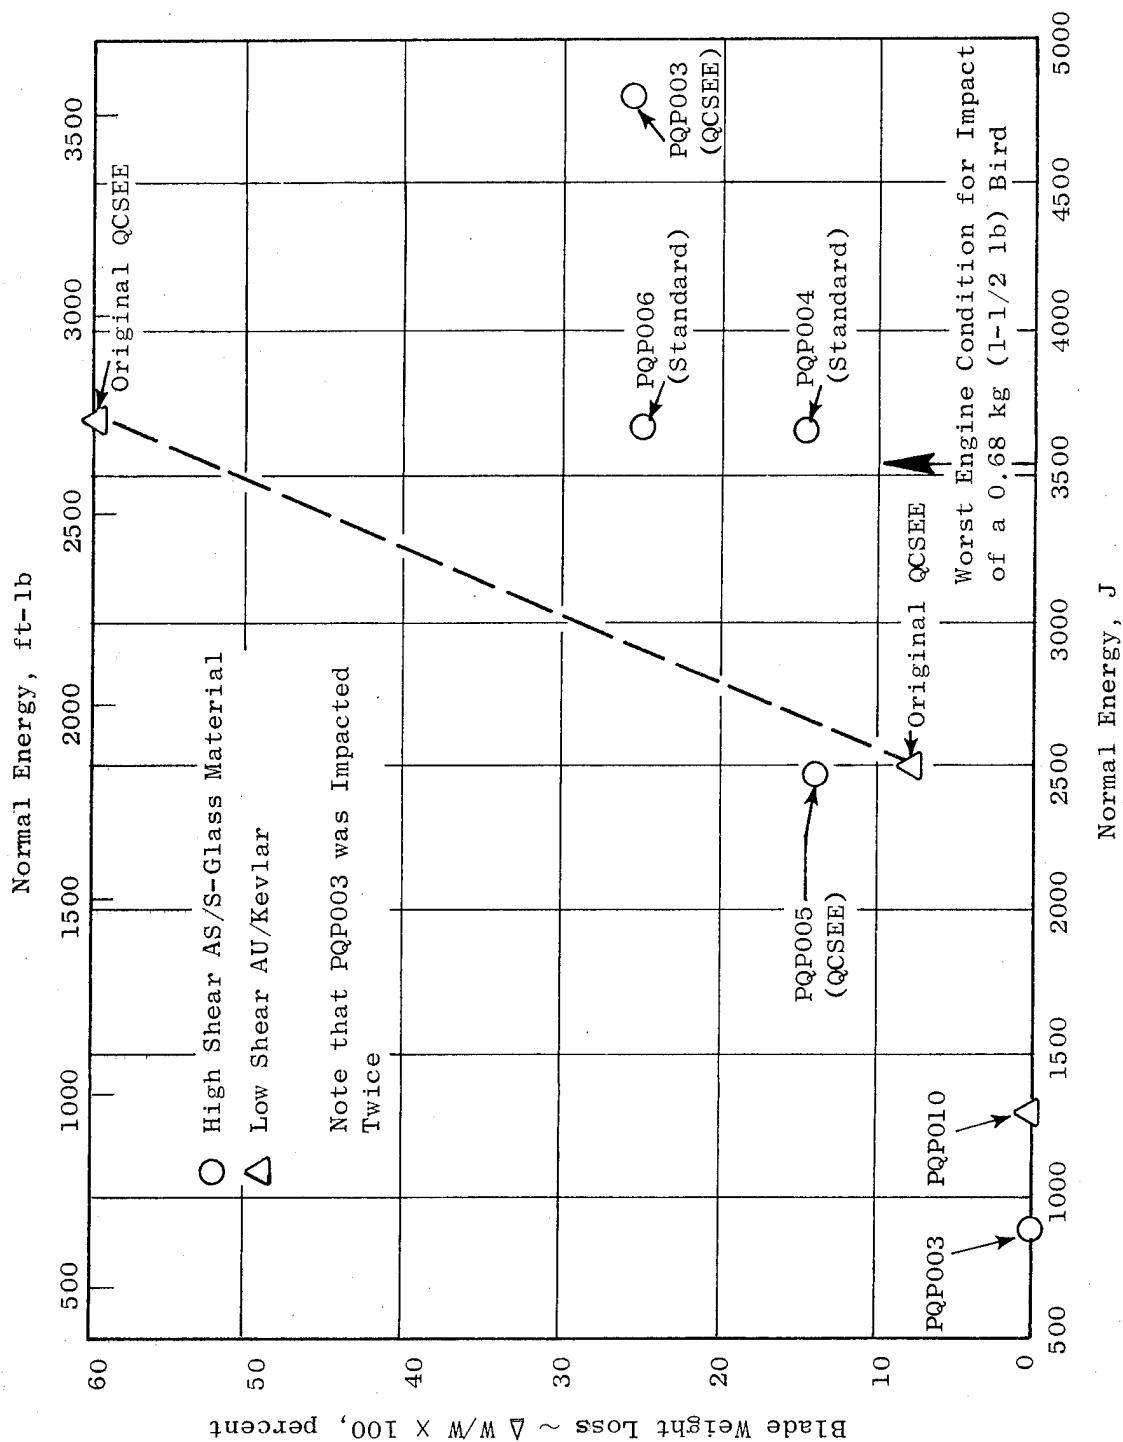
Figure 90. Blade Weight Loss for 75% Span Impact Tests.

- For the impact of a 0.68 kg (1-1/2 pound) bird at takeoff engine conditions, the improved blades with high shear materials show substantial improvement in FOD capability. The new blades exhibit a weight loss of 15 to 25 percent versus over 60 percent for the low shear material blades and an area delamination of 65 to 70 percent versus 100 percent for the low shear strength blades.

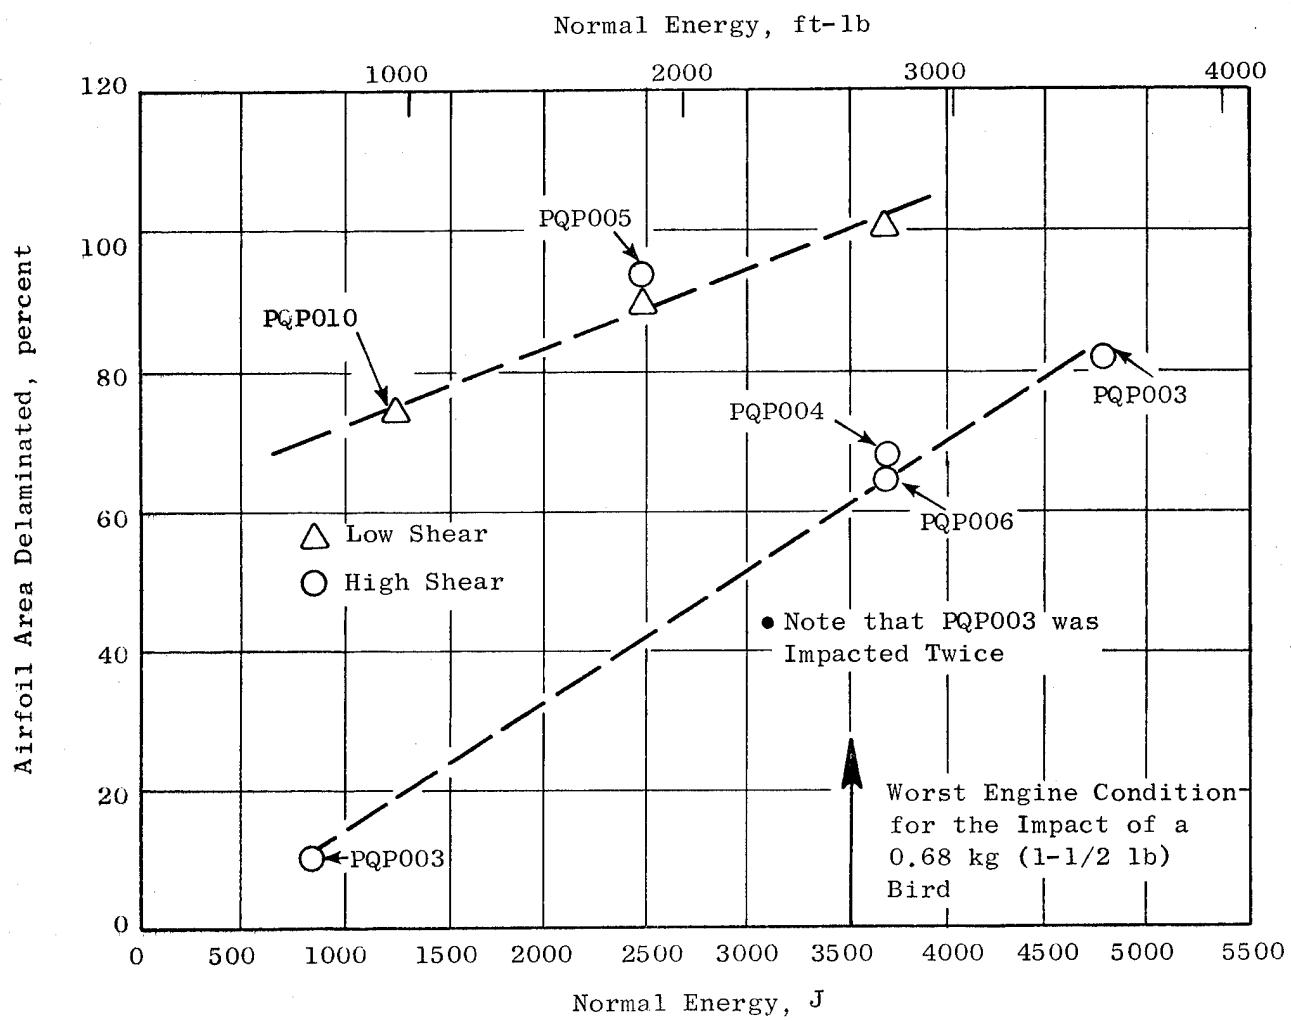
Figure 91. Airfoil Area Delaminated.

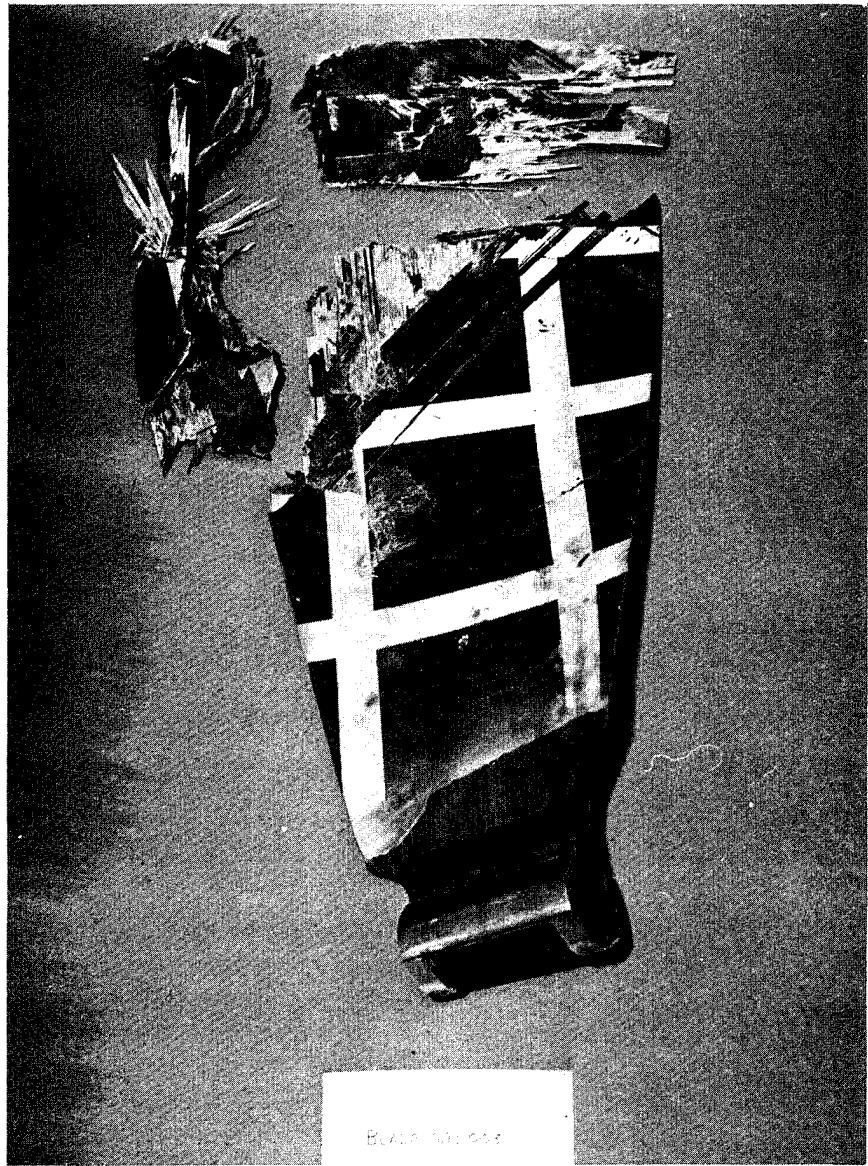
- Observation of the failed blades suggests the standard-type layups PQP004 and 006 appear to lose a region at the leading edge tip when impacted, whereas blade PQP003, having the QCSEE design, lost the entire outer portion of airfoil. At lower span impacts, this characteristic of the QCSEE layup could result in worsened FOD capability relative to the standard layup.

Figure 92. Blade PQP003 Concave Side after Impact.

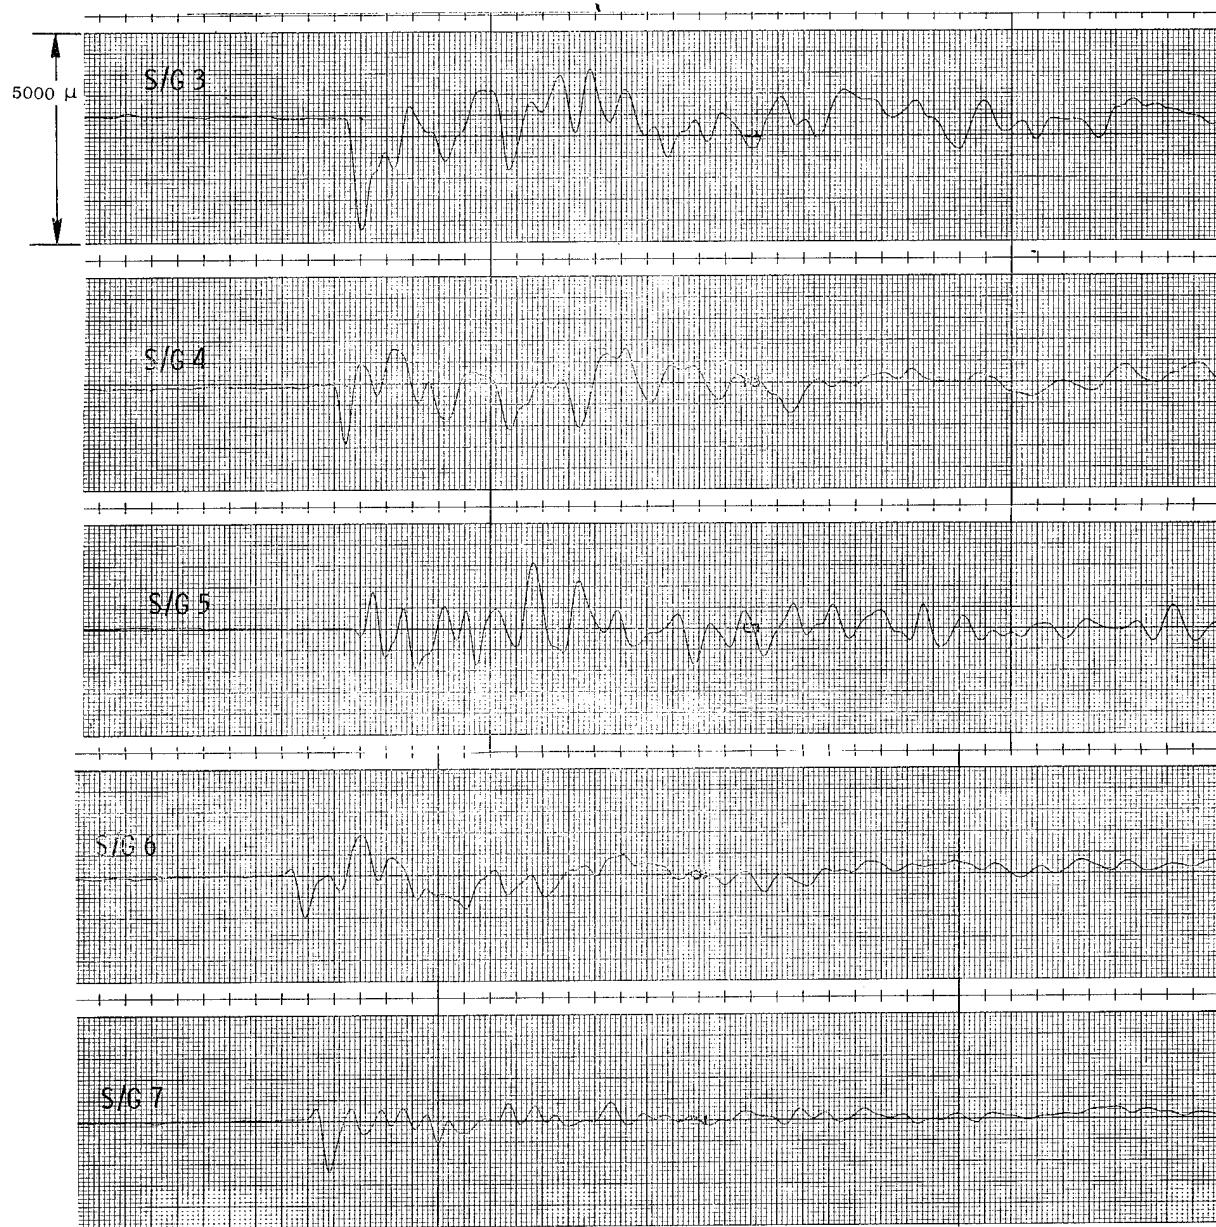
Run No. 8

14 gm Slice
75% Span
3200 rpm
33° Incidence Angle

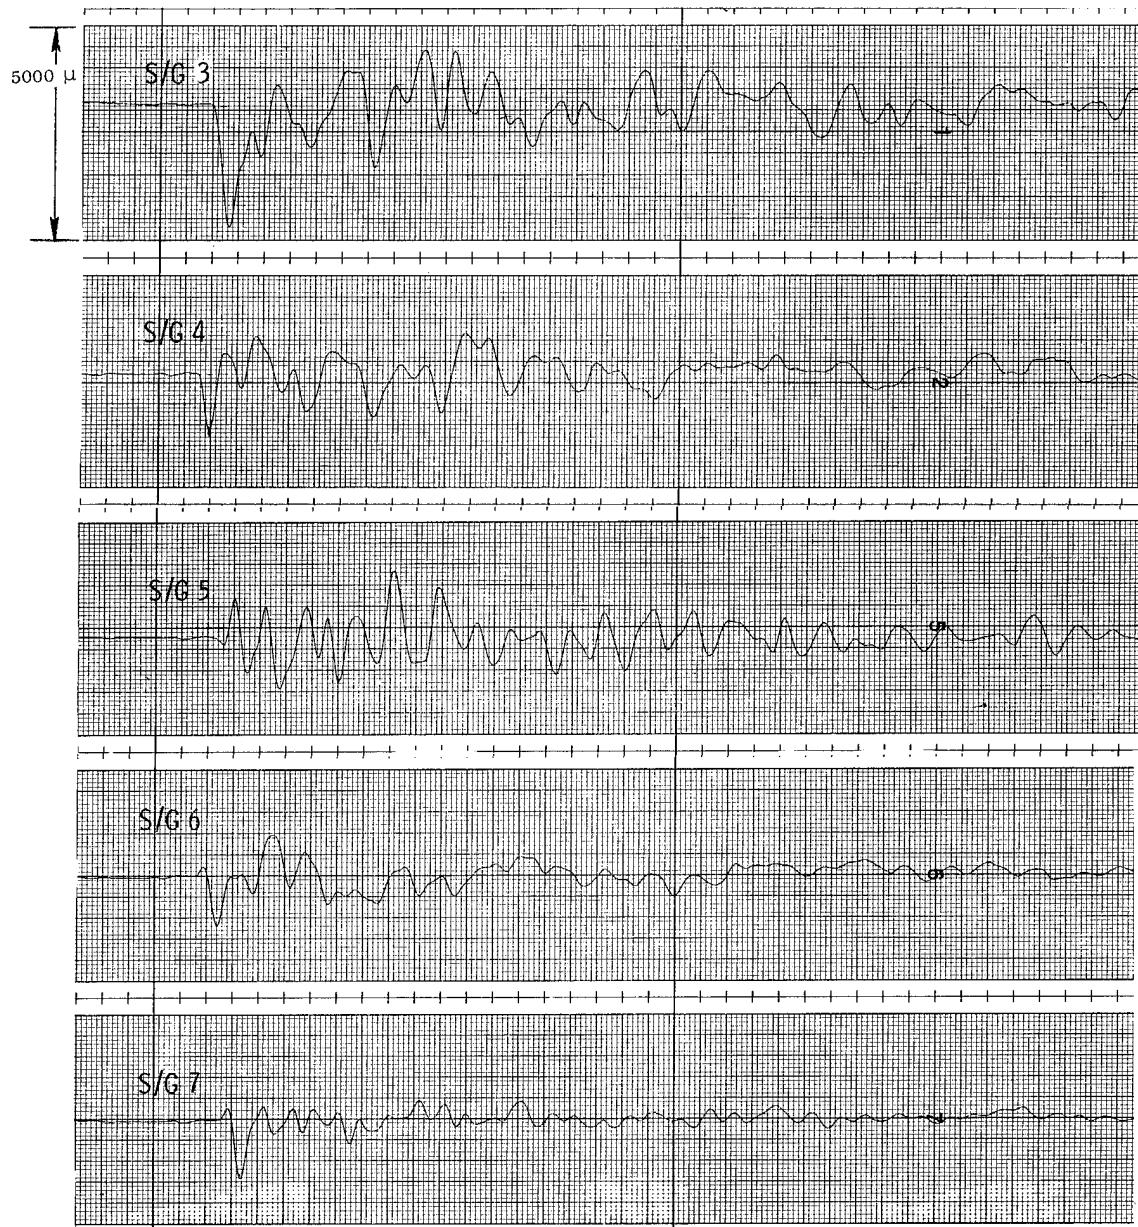
Run No. 9

12 gm Slice
75% Span
3804 rpm
33° Incidence Angle

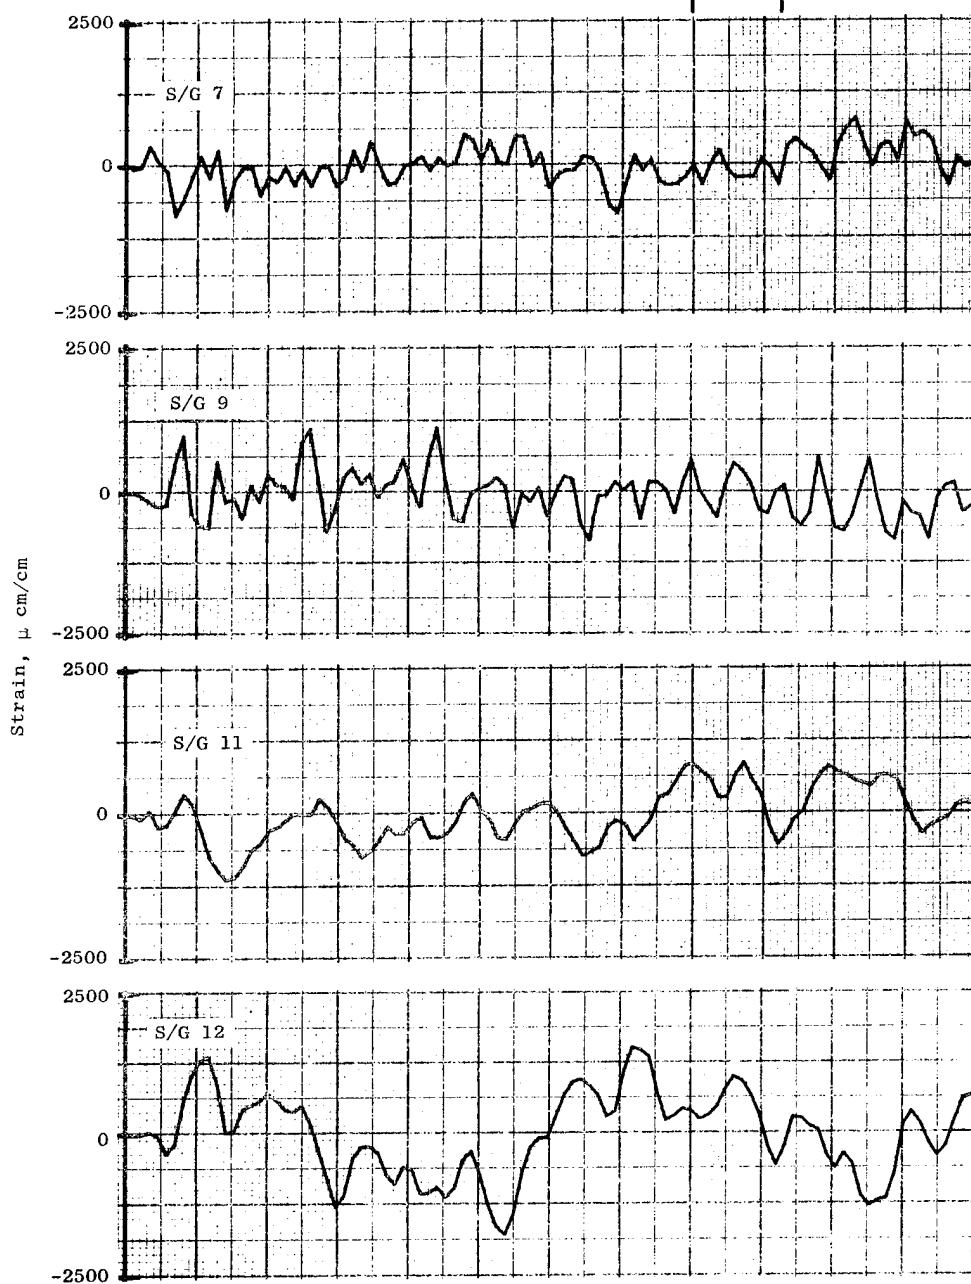
- Run No. 1
- 16 g Slice
- 75% Span
- 3200 rpm
- 23° Incidence Angle

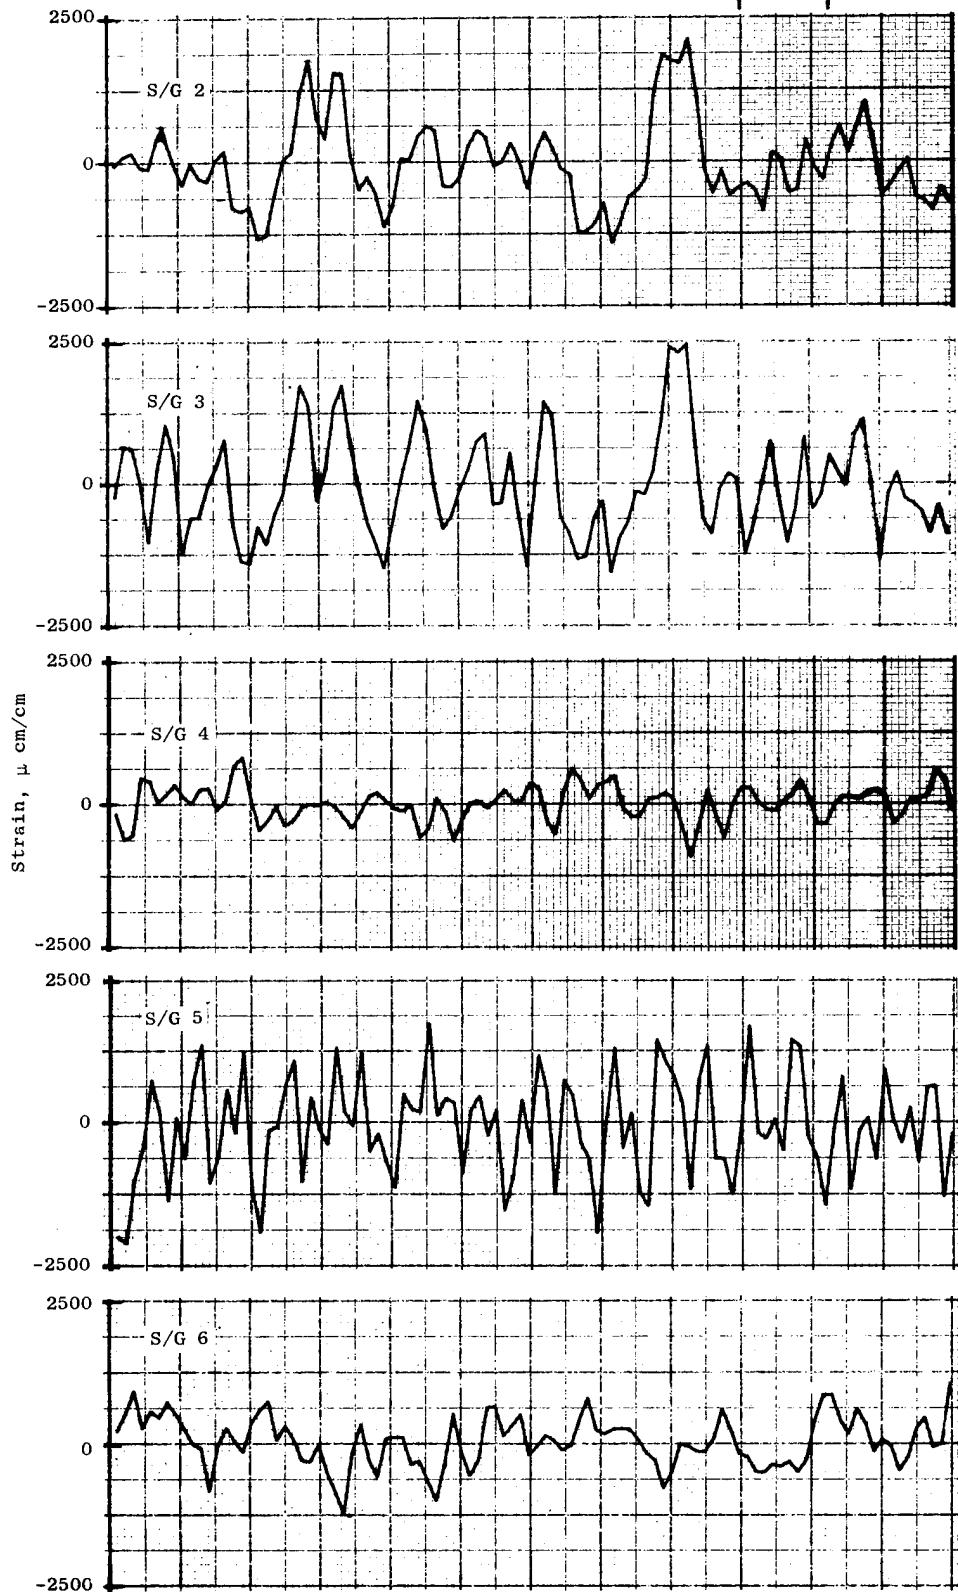
- Run No. 5
- 18 g Slice
- 37% Span
- 3202 rpm
- 40° Incidence Angle

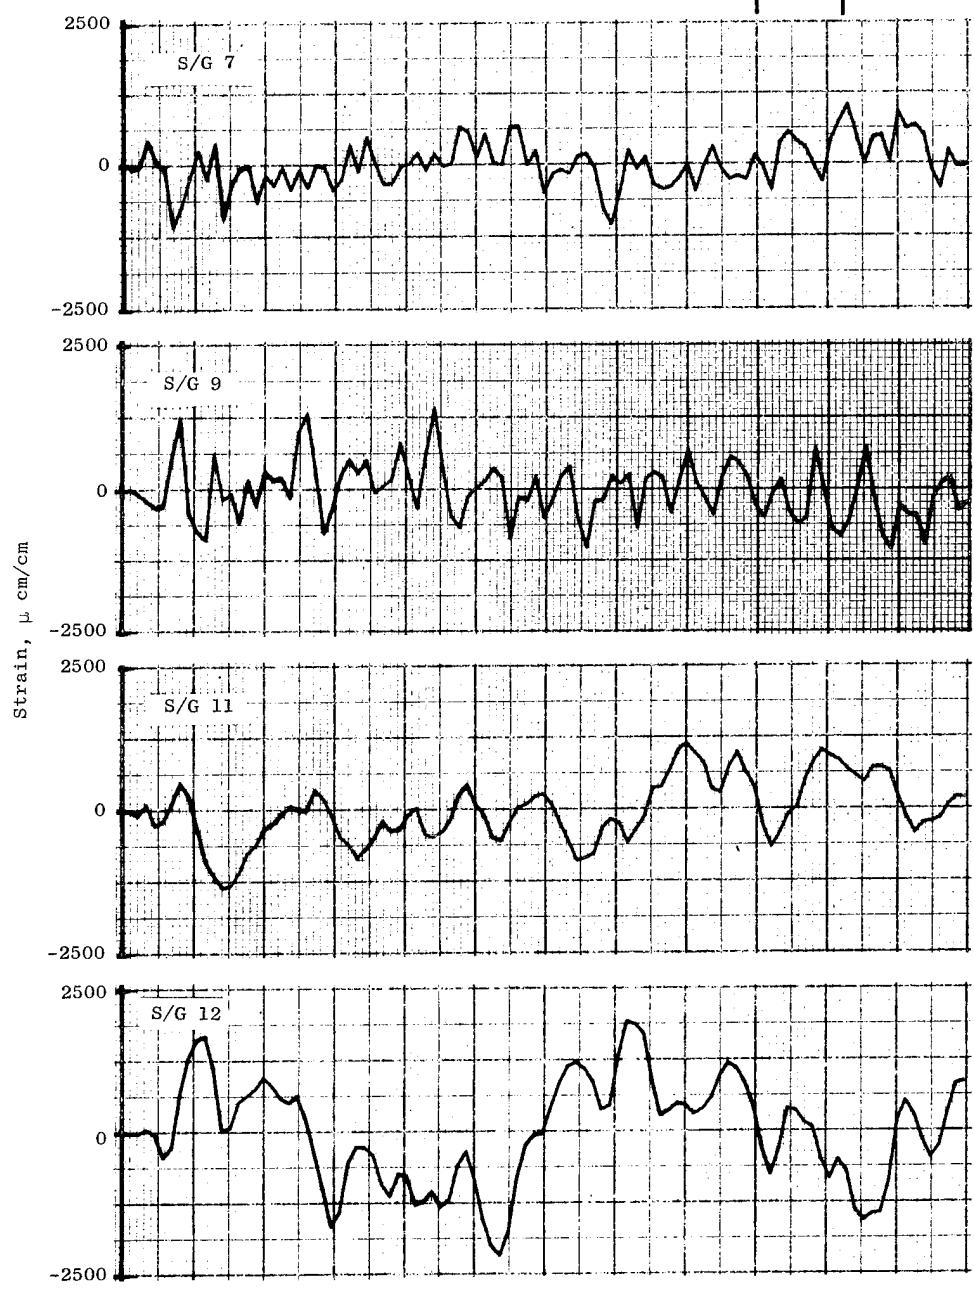
- Run No. 8
- 14 g Slice
- 75% Span
- 3200 rpm
- 33° Incidence Angle
